1st Edition,
April 2024

FUYO NEWSLETTER

01- Message from
Director Noami san
02- Observations from
External Inspections
03- Lessons learnt from
Injuries
04- Lessons learnt from
Incidents
05- Analysis of Near Miss
06- Learning from Sub
standard Conditions
07- Learning from Sub
standard Practices
08 & 09- Sharing of Best
Practices from fleet
10- Contribution from
Operation Team
11- Contribution from
Technical Team
12- Contribution from
Crewing Team
13- Contribution from IT
Team

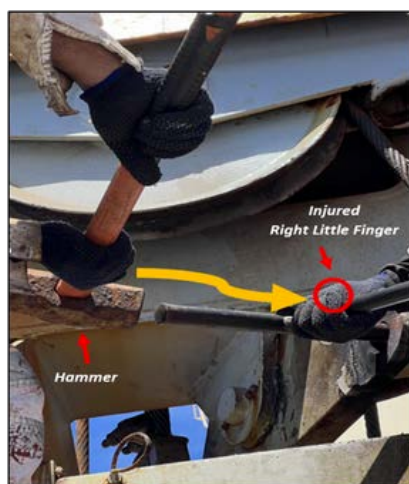
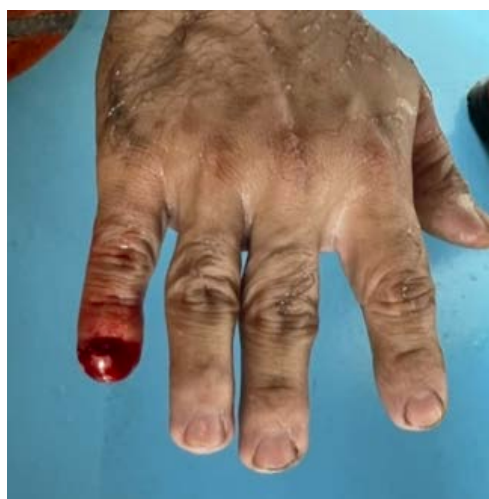
Finger Injury to AB while maintenance of Grab Bucket

While Underway, Bosun and AB was doing maintenance and wire replacement of No.1 Grab bucket. To take out wire pin, Bosun was hammering while AB was holding with hand. Accidently hammer slipped and hit right hand of AB causing injury to little finger. First aid was provided and later he was signed for medical treatment ashore

Direct Cause: Body part in potential hazard zone due to restricted range of body movement

Root Cause: Lack of situation awareness and job knowledge

- Tool box meeting for planning work and identifying potential hazards. If necessary, don't hesitate to conduct On site Tool box meeting
- Carefully and sensibly check tools, positioning and working environment before starting work
- Vessel should identify Best practices where body parts do not come in close range of hazards during work. Such Best practices may include special tools modified for job

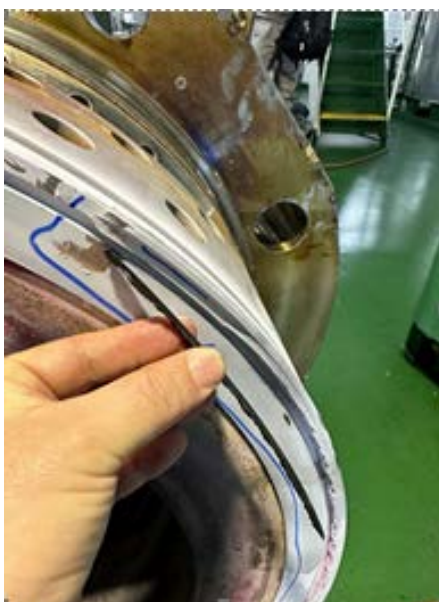
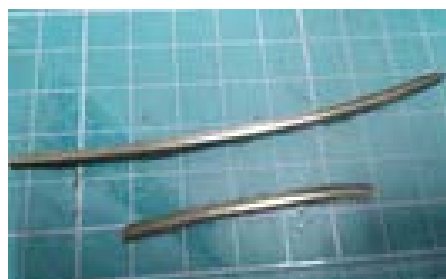
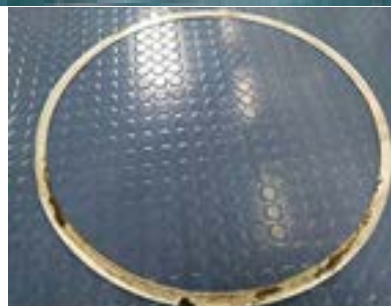
Damage of Main Engine Cylinder Cover during Maintenance

After Overhauling of routine M/E cylinder (No. 4 unit), ME was started. Engineer noticed abnormal sound and informed all concerned. M/E stopped and investigation carried out. Found damaged Fire Ring, Cleaning Ring, Cylinder Cover Grooves, Cylinder Outer Liner & scratching in Piston Crown.

Direct Cause: Vessel did not follow repair / maintenance instruction by maker while boxing back

Root Cause: Lack of experience and skill for job

On office instruction, vessel immediately replaced damaged cover with new cover along with associated spare. Once completed, M/E was restored with normal operation.

- Direct supervision by C/E during overhauling of Critical equipment such as M/E, D/G, Steering gear etc.
- Must discussion of Maker instructions and company guidance during work planning and at each critical stages such as boxing back, restoring
- Senior Officer & engineer should always mentor juniors by involving them in maintenance jobs.

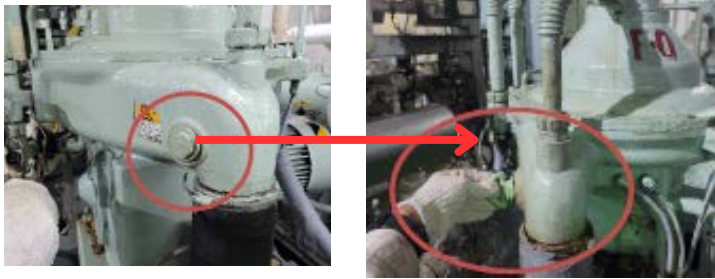
Modification of Purifier Inspection Hole Cap

It was difficult to open inspection hole as cap was standard nut and sometimes it require spanner. Spanner also causes wear & tear to Cap. Damage to cap may also cause leakages. Vessel modified cap with Wing nut arrangement and now it is easy to open by hands.

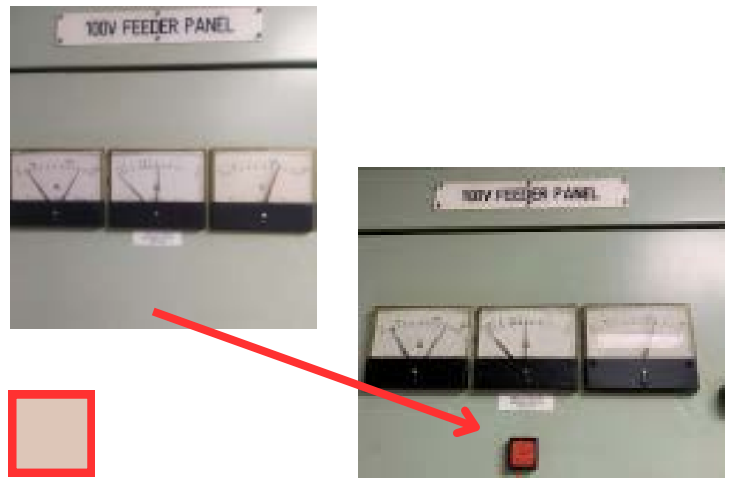
Installation of Test switch in 100 & 440 V Feeder Panel

Since delivery, vessel did not have Insulation test alarm switch in ECR. Vessel laid up cables and installed test switch so that vessel can demonstrate testing.

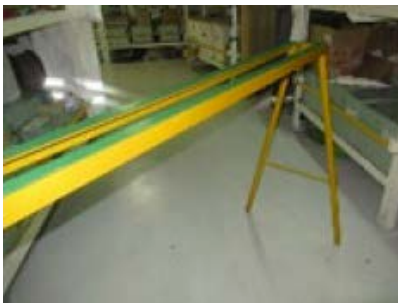
Fabrication of Piston Rack for DG

During overhauling of DG, There is high possibility of piston damage due to improper handling once dismantled.

Vessel fabricated piston rack so that pistons are properly inspected with less chance of mishandling.

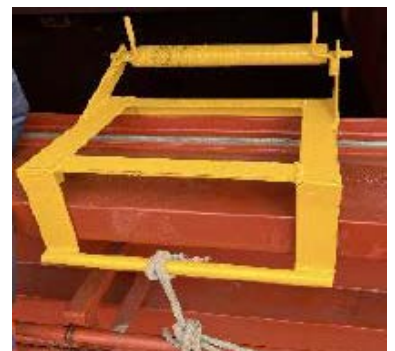
Fabrication of detachable roller for Hatch Coming

During Hold cleaning, Lowering and picking up materials is very difficult due to coaming. Also it posses hazards for personnel injury.

Vessel fabricated detachable roller which can be installed on coaming during cleaning.

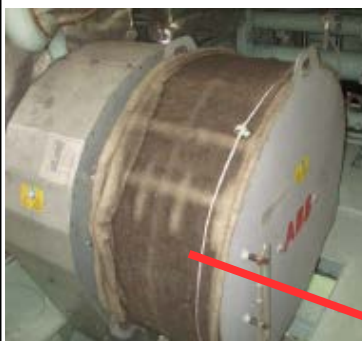
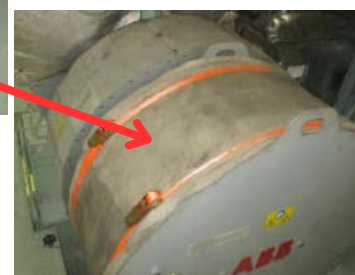
Using Ratchet type strap for tightening Turbo Charger filter

Vessel using rope to tighten filter on turbo charger filter which get loose and misaligned. Instead of rope, vessel started using Ratchet type strap which keeps filter aligned and secured properly. It is readily available also.

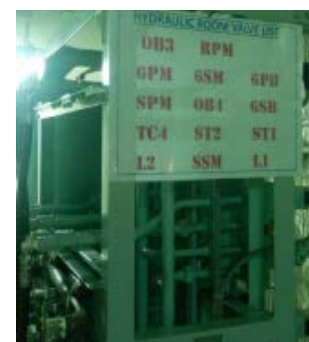
Posting of List of Valves in Hydraulic Room Panel box

During Cargo operation, sometimes trouble occurs with remote control of hydraulic valve and emergency handpump usage is required. For immediate action in case of trouble, vessel posted list of valves in each panel box to provide easy identification

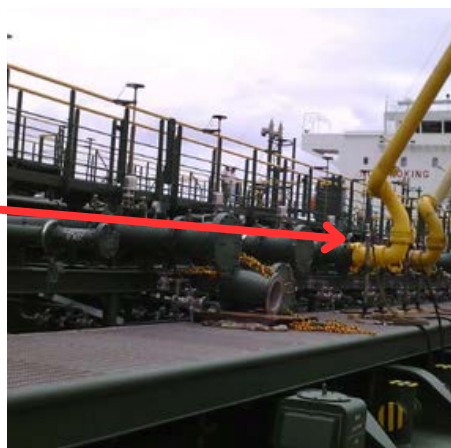
Operation - Delay in Loading Port due to Manifold Height Restriction

When vessel berthed at the S-Oil terminal, manifold height restriction was recognized during the manifold connection and hence, immediately arranged pilot to minimize berth stay and shifted the vessel back to anchorage. Charterers were informed about the same. Charterers changed the port rotation and vessel came alongside to another available berth to meet manifold restrictions, thereafter, shifted back KPIC terminal and completed loading operation. (S- Oil G1 terminal – KPIC #1 terminal)

Every shore loading arm have restriction to vessel manifold height which is dependent on vessel freeboard.

If height not in range, loading arm can not be connected and vessel can not start cargo operation

Direct Cause: While change in port rotation, Crew did not check manifold height restrictions

Root Cause: Lack of recognition of key parameters for cargo operation while sending revised stowage plan

1. Before sending revised stowage plan, double-check by Master and Chief officer
2. For Close monitoring & clear communication, Master Must coordinate with agent to obtain terminal information well in advance
3. If any changes in plan, critical parameters should be reviewed again before sending plan to external parties.
4. Master is final barrier for external communications and he must verify at once.
5. Discussion in Pre cargo meeting with terminal should not be limited to cargo plan only and should also include terminal information available
