# Ist Edition,<br/>Apr 2025FUYO<br/>NEWSLETTER

### **Observations from External Inspections**

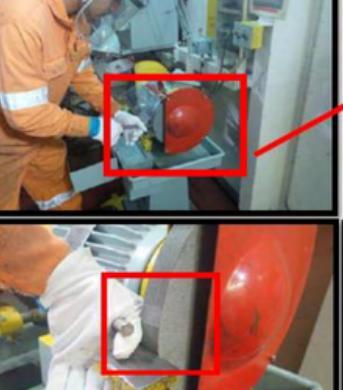
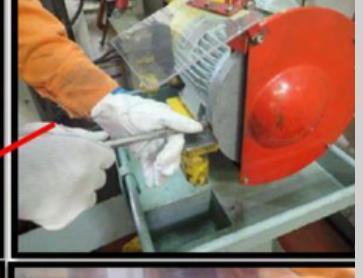
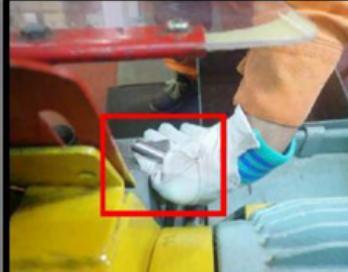
Thumb Injury by Grinder in Engine Room Workshop (Industry sharing , not from Fuyo Fleet)

While fabricating an "F" type spanner, the No. 1 Oiler was using a bench grinder to shape a bent rod. His left thumb got caught between the rotating grinding wheel and the side protection plate. The Bosun, who was nearby, quickly responded and rescued him by dismantling the grinder cover and wheel.

Thumb got caught between the grinding wheel and the workpiece.

- •Poor condition of grinder wheel
- Improper handling and technique while grinding

High-speed rotating tools can cause serious injuries if not handled properly. Awareness and correct use are critical

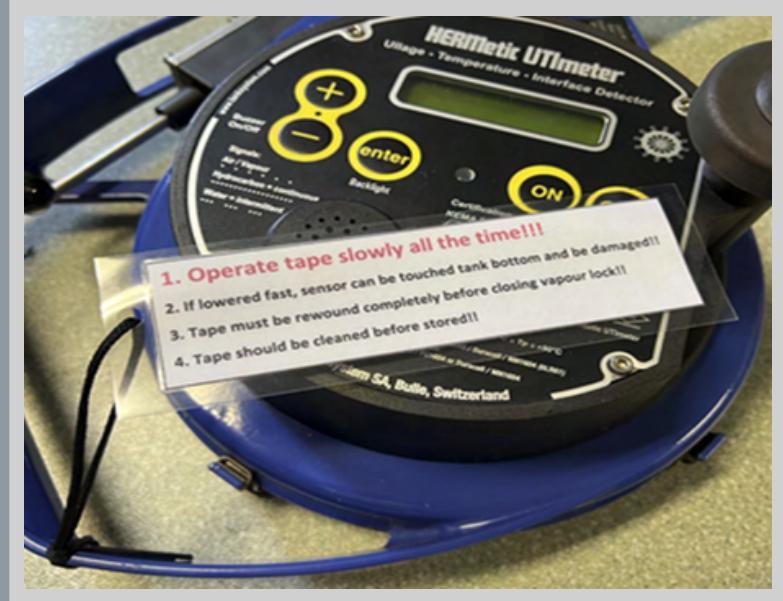
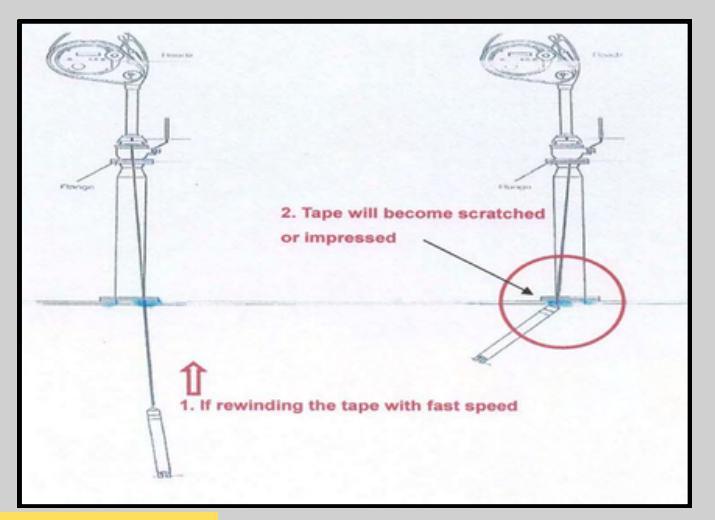
Defect Reporting and Repair Plan for Hermetic UTI Meter

On January 18, 2025, during the cleaning of the Hermetic UTI meter, a portable gas-tight measuring device on the vessel ," the UTI display unit showed a "No MSG" error alarm when powered on. According to the manufacturer's manual, this issue is usually caused by tape damage or sensor malfunction. Further investigation revealed suspected damage at the end of the tape (the sensor was confirmed to be functioning normally).

The tape is suspected to be damaged.

The UTI tape defect occurred due to the product's lifespan and improper handling.

To prevent recurrence, the UTI tape must be handled carefully. A warning to operate the tape slowly and carefully is posted near the UTI storage area.

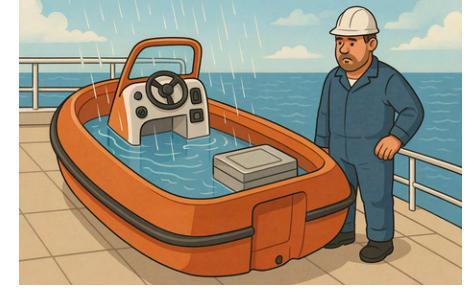
Rescue Boat Left Unchecked After Rain – Risk of Electrical Damage

During deck maintenance, Crew noticed the water did not drain properly after the previous rainfall

Remind PIC to inspect and maintain drains regularly to prevent clogs, water buildup, and equipment damage.

Weekly and post use checks to include drain check monitored by senior officer

All checks of lifeboat to be done for securing after use/drill.

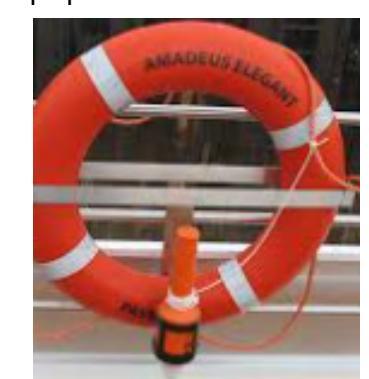
the light buoy improperly stored in the midship store

During a routine inspection, Crew noticed the light buoy in the midship store was activated and the battery drained.

Third Officer to ensure LSA/FFA readiness at all times, verified by Chief Officer.

• Educate the crew to

maintain the safety equipment

Check proper stowage of spare LSA/FFA items

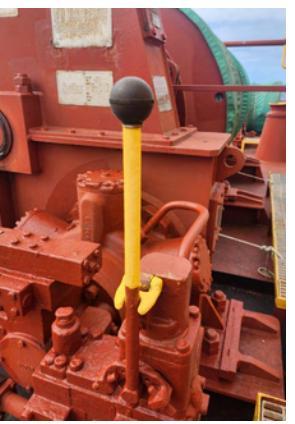
#### Unsecured Mooring winch operating Lever

During port operation, after turning on the hydraulic motor system, Crew noticed one of the winches was already running. It turned out that the handle was not in the idle position.

Remind deck crew to check equipment properly when securing to avoid accidents or damage.

• Explain crew for good practice and consequences

Always lock lever of mooring winch after use

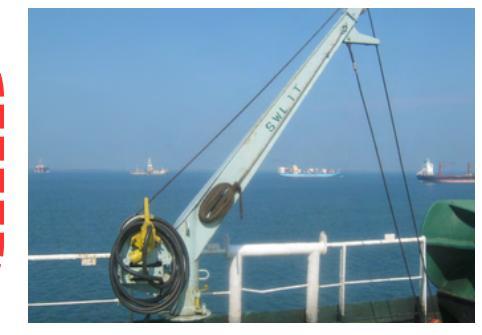
Securing Pin Missing on F.O. Hose Davit

F.O. hose davit securing pin was missing, risking the davit swinging in rough seas.

After using, put pin in place for securing at sea.

• Discuss with crew equipment after use and risks from poor practices during the toolbox meeting.

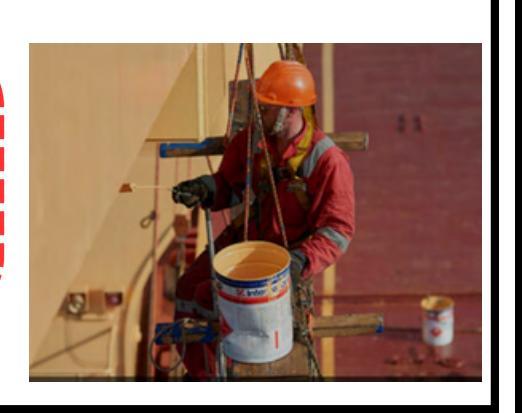
Forget to war Harness for Working aloft permit related jobs

During maintenance on deck ,Crew was painting in strong wind without a harness.

The crew should promptly execute a stop work attitude.

• Weather conditions to be ascertained before commencing work

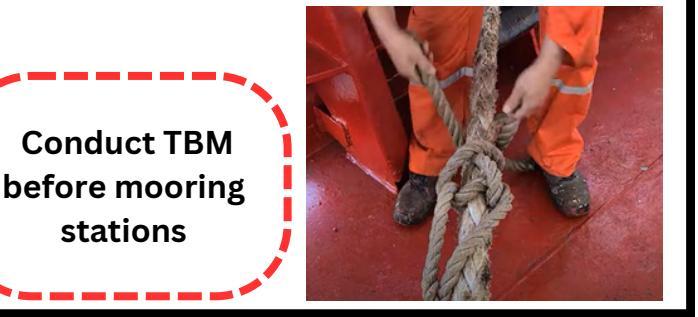
# Holdiing Tug Line without taking rope stopper

**Outline:** During mooring, crew attempted to hold the tug line with his body instead of using a rope stopper.

Discuss in the next meeting and remind of tug and mooring rope dangers to prevent recurrence.

- Practical training for rope handling
- Tool box meeting before mooring

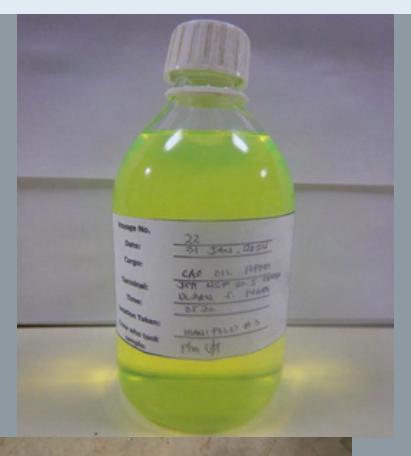
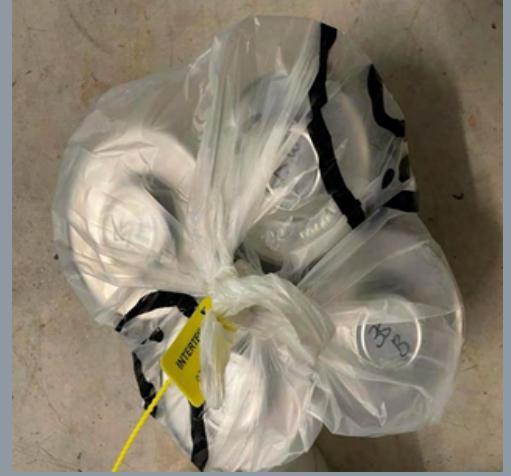
### Case Report: Off-Spec Gas Oil (10ppm) Due to Shore Tank Issues

At the first discharge port, the Gas Oil sample failed due to a high FBT value (>1.30) and visible white particles.

- White particles were detected in the shore tank sample during the joint inspection.
- The exact chemical origin remains unclear, but a chemical specialist suggested it may be due to reaction with additives in the tank.
- The shipboard cargo sample passed at the load port, but failed at the discharge port, indicating possible settling of particles at the bottom of the tank during the long voyage.

Take samples immediately at the beginning of loading (first flow), not 5–10 minutes later.

If multiple manifolds are used, take a sample at each manifold.

Check the color and clarity of the cargo. If particles or discoloration are observed, report immediately to the CCR, then the Master and Fuyo OPS with photos.
