**2nd Edition,
Aug 2025**

FUYO NEWSLETTER

Observations from External Inspections

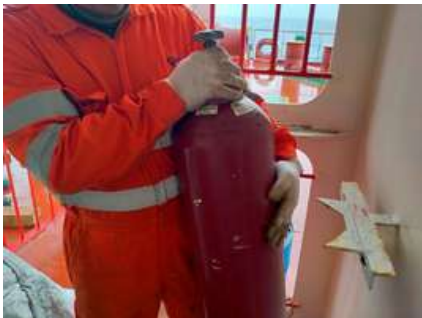
A crew member sustained a finger injury while handling an acetylene bottle inside the storage room. His left hand was unintentionally pinched between the bottle and the securing rack, resulting in fractured finger bones. The injured crew member was given medical attention and later repatriated to his home city for further treatment and rest.

OS Samson moving and securing the empty Acetylene Bottle to its securing rack.

- Use correct PPE suited for the task.
- Provide close supervision to newly promoted crew.
- Ensure task-specific training and PPE checks are in place.

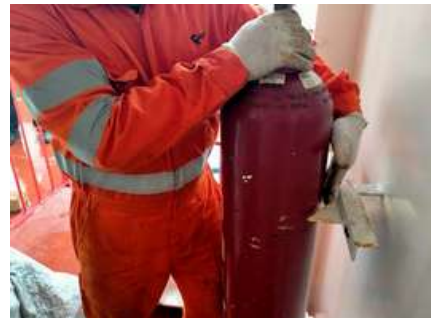
Direct Cause : Improper hand placement and use of unsuitable cotton gloves during handling.

Unaware that while hugging the acetylene bottle, his left fingers were caught and pinched in the securing rack.

Root Cause : Lack of experience and job-specific safety awareness after recent promotion.

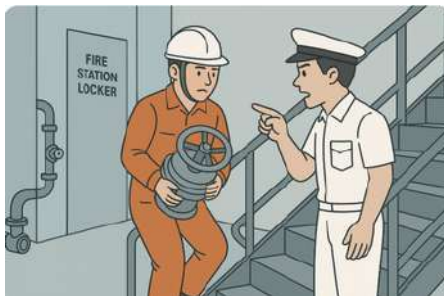
Not Using Handrails While on Stairs

An engine crew held a valve with both hands while walking upstairs, not using the handrails.

Crew must follow the 3-point rule in using ladder / staircase.

Recognize that unsafe behavior can cause injury, and take strict measures to prevent recurrence.

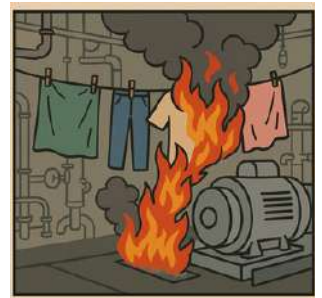
Wet Clothes in Engine Room

Wet clothes were found drying in the engine room during sailing.

Crew must dry wet clothes only in the drying room; no wet clothes should be left outside for safety.

Chief Engineer educated all engine crew to keep wet clothes in the dry room to prevent fire hazards.

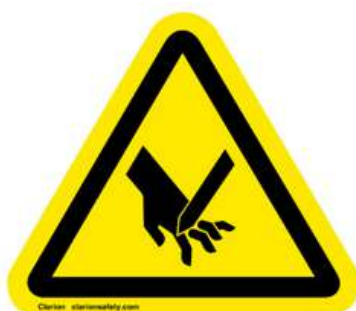
Unsecured Cutter

An unsecured cutter was found on the floor near the incinerator during routine rounds.

The cutter must be secured to a safe area immediately

Install proper warning signs and markings to ensure tools are secured as per procedures.

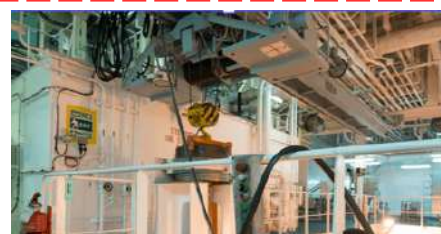
Hand Near Pinch Point During Crane Operation

Crew member's hand was nearly caught between the sheave and wire rope of the engine room overhead crane during lifting of the M/E exhaust valve.

Training should be conducted as per COSWP guidelines.

Discuss safety precautions and raise awareness

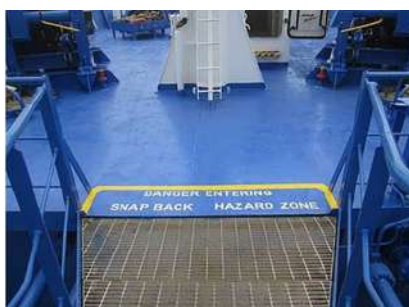
Crew in Snap Back Zone During STS Mooring

The crew should promptly execute a stop work attitude.

- Reminded all deck crew of the dangers of the snap back zone during the toolbox meeting.
- Conduct on-site training on snap back zones with practical demonstrations.
