3rd Edition, Oct 2024

FUY0 NEWSLETTER

50 Years journey of Fuyo Kaiun (1974-2024)

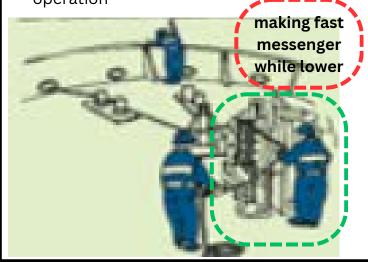
Uncontrolled release of Tug Line during Cast off

During unberthing station, Crew released tug line in uncontrolled manner after Tug cast off

Crew must secure messenger of Tug line in bitt and lower them slowly.

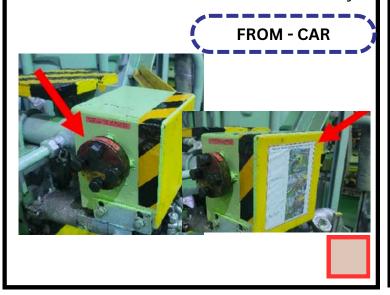
Special Tools at Local Position of M/E starting airline

In Maneuvering, response time is less to repair rupture disk trouble. Vessel installed special tools and recovery procedures nearby so that immediate action can be taken without delay.

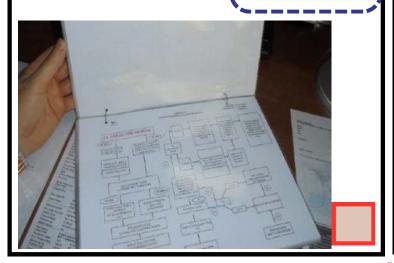
Handy and Ready to use Emergency Flow charts

SMS Emergency flow charts were vertical orientation and not handly for printouts.

Vessel adjusted size of text windows and placed on bridge for case of emergency
