4th Edition, Jan 2025 FUYO NEWSLETTER

Observations from External Inspections

Lessons Learnt from Injuries

Lessons Learnt from Incidents

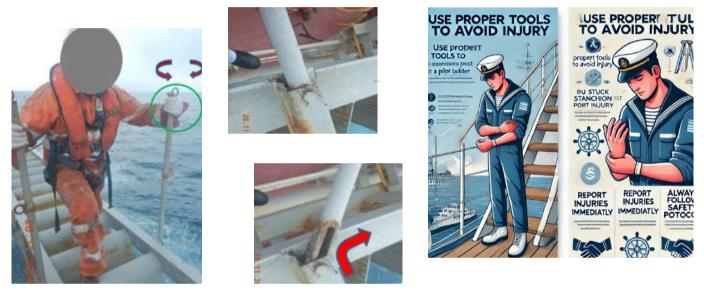
Bosun left wrist injury during securing of combination ladder (Port side)

During the preparation of port side combination pilot ladder, OS was pulling one of the jammed stanchion using all of his force to remove it. Unfortunately, during pulling, his left wrist accidentally twisted which caused pain in his wrist.

Twisting of wrist while putting excessive force when attempting to remove a jammed stanchion post

• Rushing for the job to remove jammed stanchions

- Lubricate movable parts in working condition to avoid panic
- Inspect Gangway and Pilot ladder 1 day prior arrival
- Call for assistance when job is not going as planned
- Never rush for job completion. Things may not go as planned

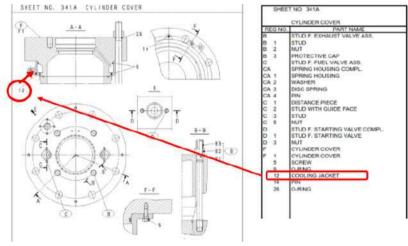
Cooling Jacket Crack and Water Leakage

While en route, the main engine's No. 1 cylinder cover cooling jacket developed a crack, causing water leakage. The vessel was stopped for repairs, during which the damaged jacket was welded and temporarily restored.

Direct Cause:The crack in the main engine's No. 1 cylinder cover cooling jacket caused water leakage, requiring immediate repair to restore engine functionality.

- Low Nitrite level in Cooling water due to Inadequate Chemical dosing
- Lack of supervision for onboard chemical testing

- Timely Detection and Action: Regular monitoring and prompt repairs are critical to minimizing downtime and preventing further damage.
- Preventive Maintenance: Maintaining proper nitrite levels and conducting routine inspections are essential to avoid similar issues.
- Preparedness: Ensuring critical spare parts are available onboard reduces delays and enhances operational reliability.
