2nd Edition,
July 2024

FUYO NEWSLETTER

Lessons Learnt from Incidents

Damage of Main Engine Lube Oil Pump Motor

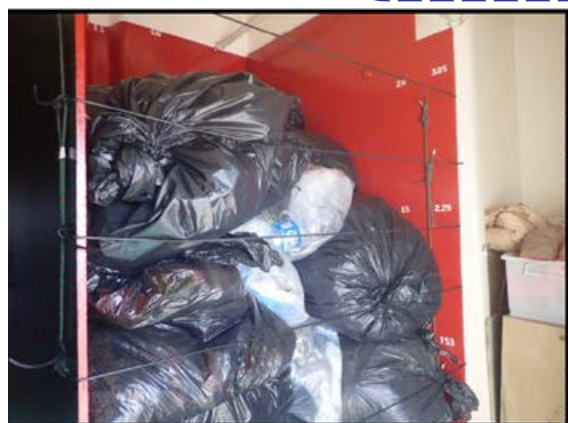
Installing Divider in Garbage store for good segregation

Outline:

Garbage segregation is critical for environment and also for hygiene management.

Quantity graduations will help for good estimation of quantity for declaring to shore reception.

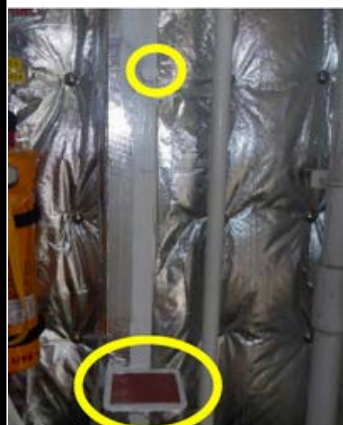
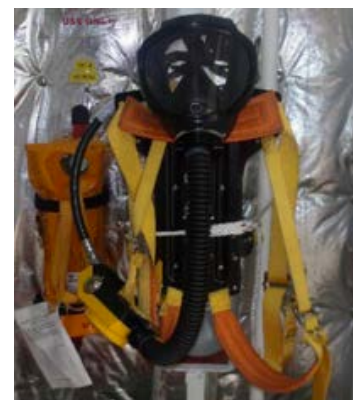
For quick donning of SCBA suits, made holding bracket in locker

In stowage location, Vessel installed brackets so that SCBA sets can be hanged and quickly deployed by Fire man in case of emergency.

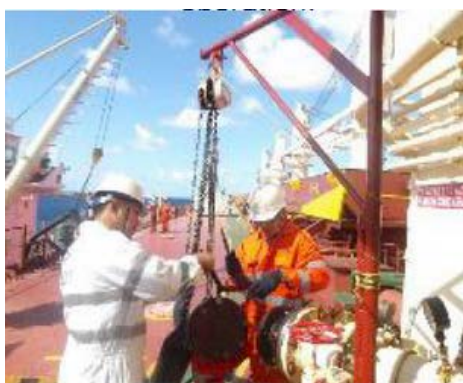
Fabrication of detachable stand for lifting bunker hose

For safe and smooth connection operation of bunkering hose, detachable stand fabricated by ship staff. It can be deployed easily near bunker manifold and transfer weight of flange using chain blocks and slings.

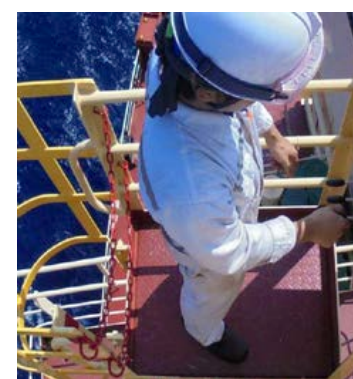
Fabrication of additional chain support in Railing

In provision crane working area, no barrier was available even working at height. Vessel installed chain support so that crew can work with free mind ensuring fall protection is available.

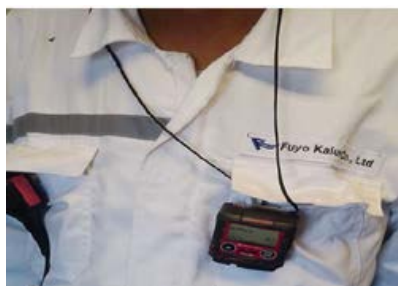
Strap provided for Gas detectors to prevent fall

Vessel faced one unfortunate event as pocketable detector was fallen from crew pocket while working on deck.

AS detector need to be carried during cargo watch or tank inspection, there is high possibility of recurrence. Vessel attached strap to detector to prevent from falling.

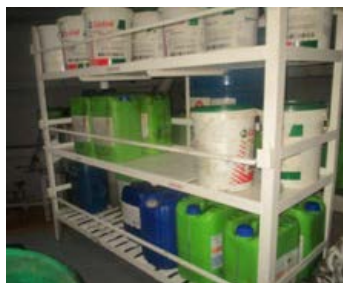
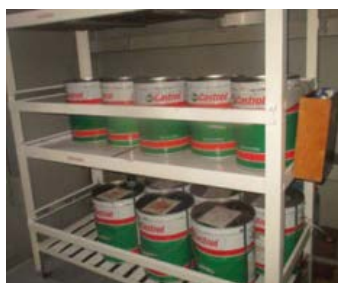
Repainting chemical rack in white to easy spotting leakage

Sometimes chemical start leaking if stored over long period. It is dangerous to lift them without knowing leakage.

Vessel painted rack floor with white paint so that leakage will be readily apparent and crew will take extra caution while handling those.

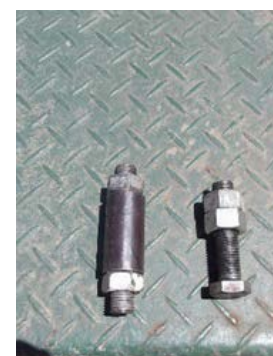
Fabricated special tool for pushing wire end during replacement

During replacement of hoisting wire, wire end pin to be pushed. Due to limited space, There is possibility of finger getting injured. CE fabricated special tool which can work effectively to remove wire end pin.
