FUYO NEWSLETTER

Lessons Learnt from Incidents

Machinery Incident - Windlass No. 2 Shaft Bearing Failure

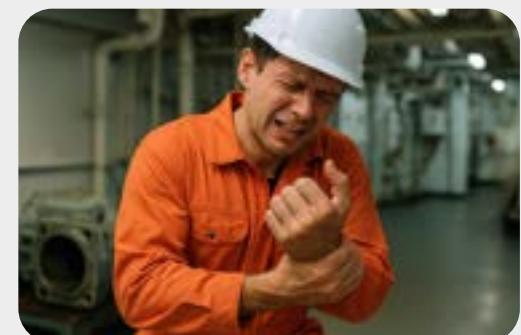
During the overhauling job of a generator, a crew member attempted to lift and move a heavy cylinder head alone. As a result of this action and overexertion, the crew member suffered a sprain on the right wrist. The injury was later diagnosed as De Quervain's tenosynovitis, a painful condition where the tendons on the thumb side of the wrist become inflamed.

Direct Cause : The crew member tried to move a heavy object (cylinder head) alone, leading to overexertion and wrist injury

Crew trying to move the heavy cylinder head alone

- Lack of safety awareness / complacency
- Lack of senior officer's supervision / lack of communication
- Improper positioning during the lifting task

- Specific discussion is required in toolbox meetings (TBM) if heavy lifting or moving jobs are planned.
- Periodic training for all crew members on proper lifting postures is necessary.
- Developing a “Stop Work and Help” culture requires direct involvement from senior management onboard

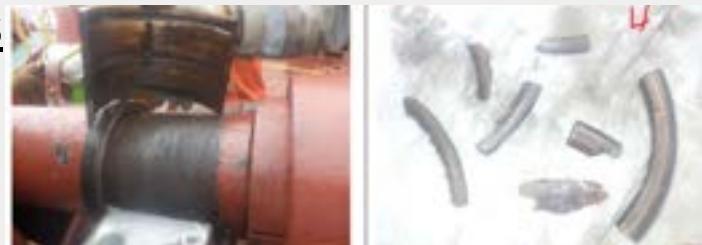
During routine inspection after arrival at Kandla, the deck department discovered a fragment of a brass shaft bearing on deck near Windlass No. 2. Vessel dismantled shaft & shaft bearing. Found all three locking pins broken. It seems cracked brass shaft bearing caused damage to the pins. Vessel cleaned thoroughly & regreased with the appropriate grade of lubricant. The shaft and bearing were reassembled with proper alignment.

- Cracked Brass shaft bearing causing damage to pins
- Grease holes & passages blocked with old & hardened grease

- Non compliance with standard procedure of lubrication
- Responsible crew did not check for removing old grease
- Lack of supervision for work instruction

- Without removing old grease, no point of pushing new grease so Check passage before greasing invisible parts
- CE, CO or 1AE must supervise greasing of critical machineries
- for joining crew, Senior officer MUST carryout on scene work familiarization
- **DO NOT ASSUME** that people know what to do

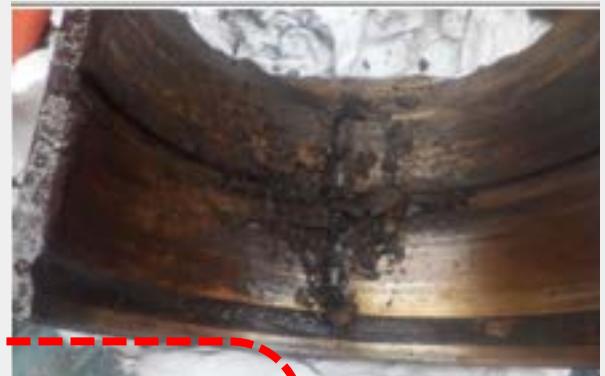
Grease holes & passage blocked with old & hardened grease

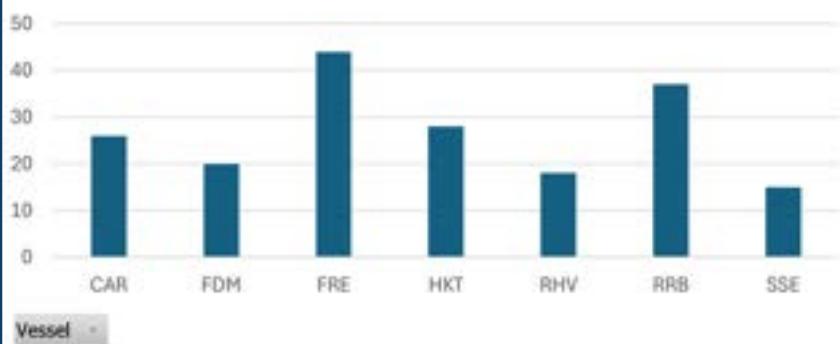
NM Submission Jul - Sep 2025

FRE showing good submission. Other vessels also need to follow same.

Identify more NM with Critical & Catastrophic potential.

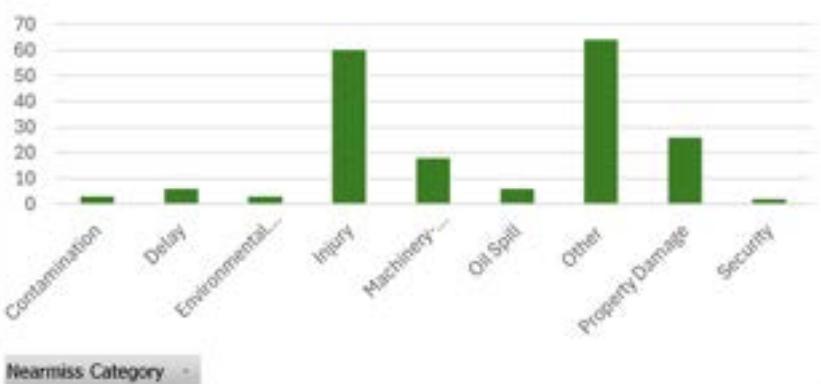
Near Miss Category

To reduce Machinery Incident, request to identify more NM in this category

Encourage crew to report NM from other important areas too.

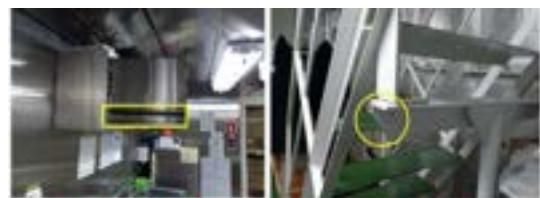
Applying warning tape to overhead shelves and stair areas within the galley to reduce the risk of personnel injury due to accidental head or body contact.

BEFORE : Potential Danger for striking against the Head

AFTER : Visual warning indicator for the crew awareness

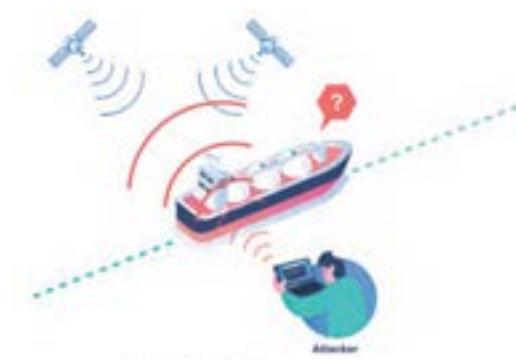
Figure 1 Jamming

- GPS Spoofing: Malicious actors transmit false GPS signals, causing ships to show incorrect position and time data.
- GPS Jamming: High-powered noise is emitted on GPS frequencies, resulting in signal loss and navigation blind spots.
- These threats have increased in recent years, with incidents reported in high-risk areas like the Baltic Sea, Eastern Mediterranean, and East Asia.
